IL RESTAURO

THE RESTORATION

Il nuovo restauro

The new restoration

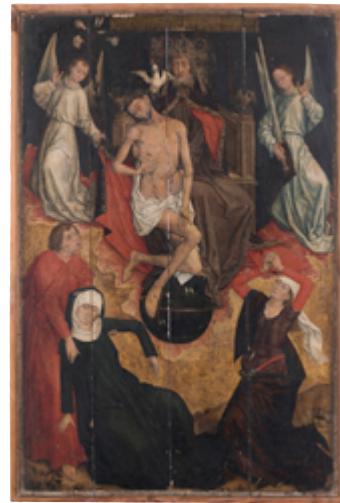
1

I. Il dipinto prima del restauro.

I. The painting before restoration.

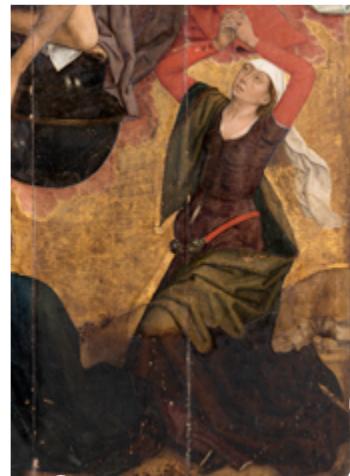
4

4. La Maddalena durante la pulitura sul verde di rame alterato.

4. The Magdalene during the cleaning of the altered copper-green.

Le assi, completamente distaccate tra loro, sono state incollate facendo molta attenzione alla coplanarità della superficie. Il nuovo telaio, più leggero, garantisce con un sistema di molle sostegno e al contempo possibilità di movimento al legno del supporto. I dislivelli sono stati risolti con delle controforme (Fig. 2, 3). La pulitura si è svolta principalmente con miscele basiche, indicate per oli e colle. Per i verdi sono stati utilizzati solventi al fine di assottigliare la vernice resinosa alterata. Le lacune sono state risarcite con stucco composto da gesso e colla e poi reintegrate ad acquarello, e in alcuni punti, con colori a vernice. La superficie, infine, è stata nebulizzata con vernice trasparente leggermente satinata (Fig. 4).

The rods, which had become completely detached from each other, were glued, taking great care to ensure the coplanarity of the surface. The new, lighter underframe uses a system of springs to ensure support while at the same time allowing the wood of the structure to move. The unevenness was solved by the use of braces (Fig. 2, 3). The cleaning was mainly carried out using basic mixtures suitable for oils and glues. Solvents were used for the greens with the aim of thinning the affected resinous paint. Gaps were filled with a stucco made of plaster and glue and then restored with watercolour and, in some places, with paint. Finally the surface was sprayed with light, satiny clear varnish (Fig. 4).
